PHASE I REPORT
NATIONAL DAM INSPECTION PROGRAM.

NAME OF DAM: Milburn Spring Dam
STATE LOCATED: Pennsylvania
COUNTY LOCATED: Bedford
STREAM: Unnamed tributary of Cumberland Valley Run
SIZE CLASSIFICATION: Small
HAZARD CLASSIFICATION: High
OWNER: Borough of Bedford
DATE OF INSPECTION: November 19 and December 12, 1979

Reservoir (NLI ID Number P1 00237,
DEM ID Number 57)
Susquehanna River Basin, Unnamed
Tributaries of Cumberland Valley
Run, Bedford County
Pennsylvania, Phase I
Inspection Report

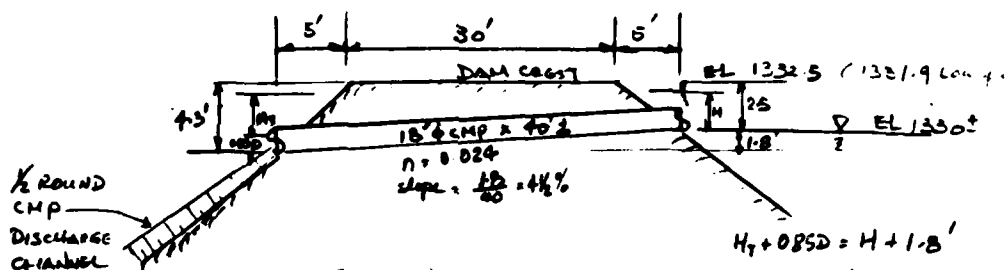
SECTION @ SPILLWAY
 (NOV 19 1979 SURVEY).

THE SPILLWAY OF THE DAM CONSISTS OF AN 18" ϕ CMP
 OVER FLOW PIPE AS SHOWN BELOW.

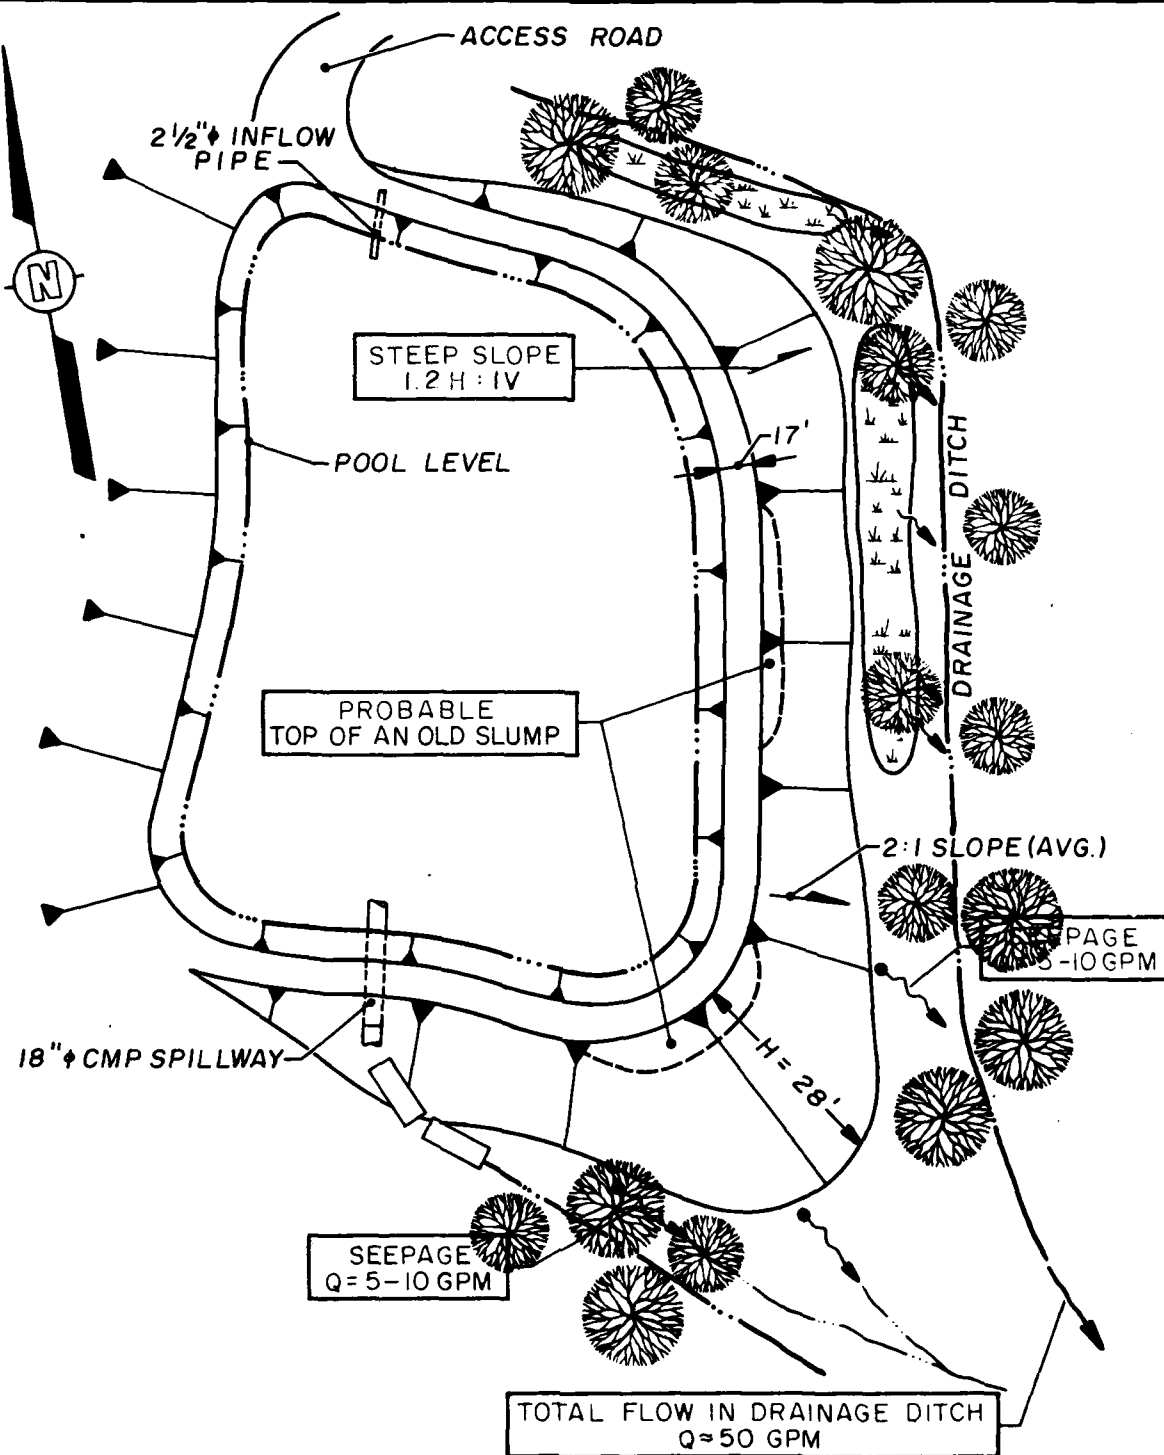
1. POOL LEVEL DATE OF INSPECTION:
0.2 FT. ABOVE SPILLWAY PIPE
INVERT
2. SEE PLATE 3 FOR INLET AND
OUTLET PIPE LOCATIONS.
